GTO Association of Maine June 2018

FEATURE ARTICLE

This is a story about how something which starts as a small repair can grow into much more. It began as we noticed a wet spot on the floor mat beneath the passenger's feet. The liquid was removed but in a few days it was back. Further examination showed it was a sticky green fluid dripping from in back of the glove box. On a '67 GTO, there is only one source for such foreign material - the heater core located in a box plenum on the passenger's side beneath the dash.

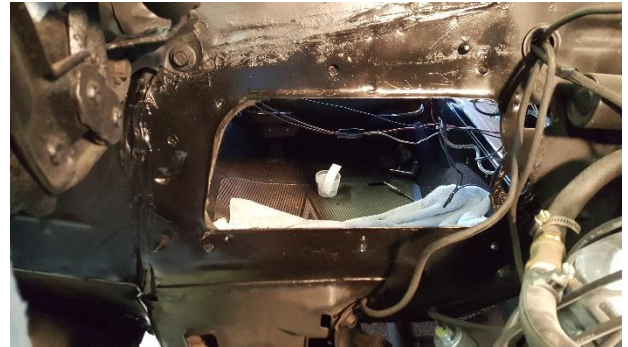
With everything apart, it only made sense to clean up the old gasket material on the firewall and repaint that area. The heater box halves were similarly prepped and at long last the new core could be installed.

Reassembly of the control cables was not too bad but I had to be very careful to route these such that they would not be kinked and would operate smoothly. A color code system makes sure that the 3 similar looking cables go to the right levers. The rebuilt heater assembly and the control panel with cables were all inched back into place slowly as a set.

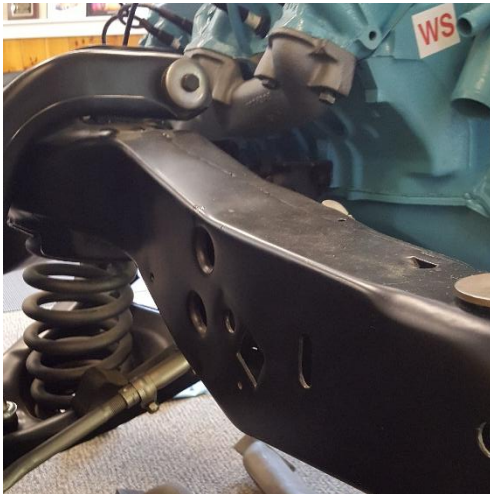
Display at Ames Performance

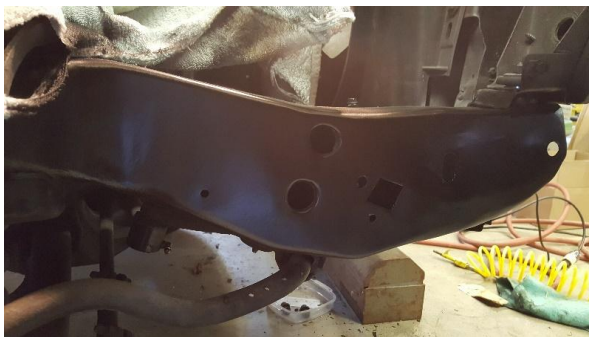
Alas, where the fender liner lands on the front ‘horn’ of the frame, I noticed something was amiss. During my trip to Ames in NH, I had photographed a built-up GTO frame on display in their show room. Let’s just say mine wasn’t as pretty. There was not a lot of damage but at some point, the car had experienced a crunch with the passenger side front bumper which in turn had put ripples in the forward part of the frame horn. A trip to Harbor Freight produced a new Porta Pak kit which enabled me to tweak the frame so it resembled what I had photographed at Ames. A little painting was in order here too.

Our frame after some clean-up
